Oliver Stewart
RAIB Recommendation Handling Manager

5 April 2024

RAIB Report: Train overspeeding at Spital Junction, Peterborough on 17 April 2022

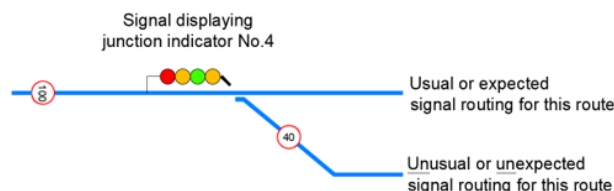
- A signal capable of crossing onto a different line, AND
- A subsequent reduction in speed of more than 30%, AND
- It is very unusual for the diverging route to be set, which could lead to the driver disregarding the route indication when the signal clears to a less restrictive aspect, and consequently accelerating to the speed for the faster route (e.g. signal normally clears onto the faster route but clears onto the slower route, example below)

We have found this to be a simple and effective means to point us towards junctions that offer a similar risk to that of Spital.
