**RAIB Report: Fatal accident involving a train passenger at Twerton on 1 December 2018**

## Initial consideration by ORR

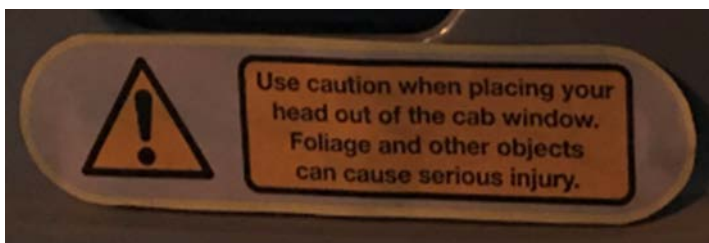
The only area that poses this risk is the side window within the driving cab of our Class 390 EMU. Avanti West Coast are implementing a fitment of a warning label within the driving cabs of these units to inform persons using the window of the dangers (example in figure 1). The Class 221 fleet do not have opening side cab windows.

Below is an example the above mentioned sticker

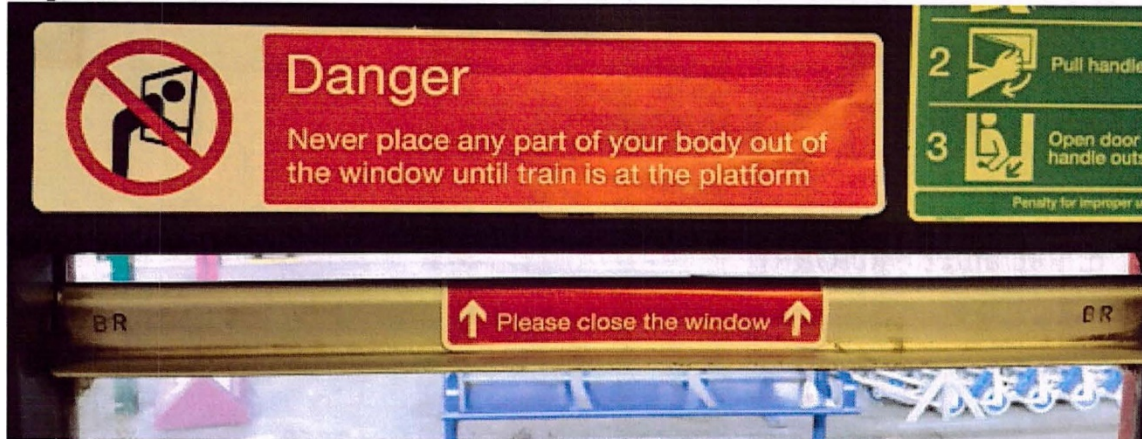
Top of window

*As part of our risk assessment for mitigating the risk of a passenger leaning out of the droplight windows on the Sleeper since 7th February 2019 we have had updated signage on our Sleeper service, as shown below:*

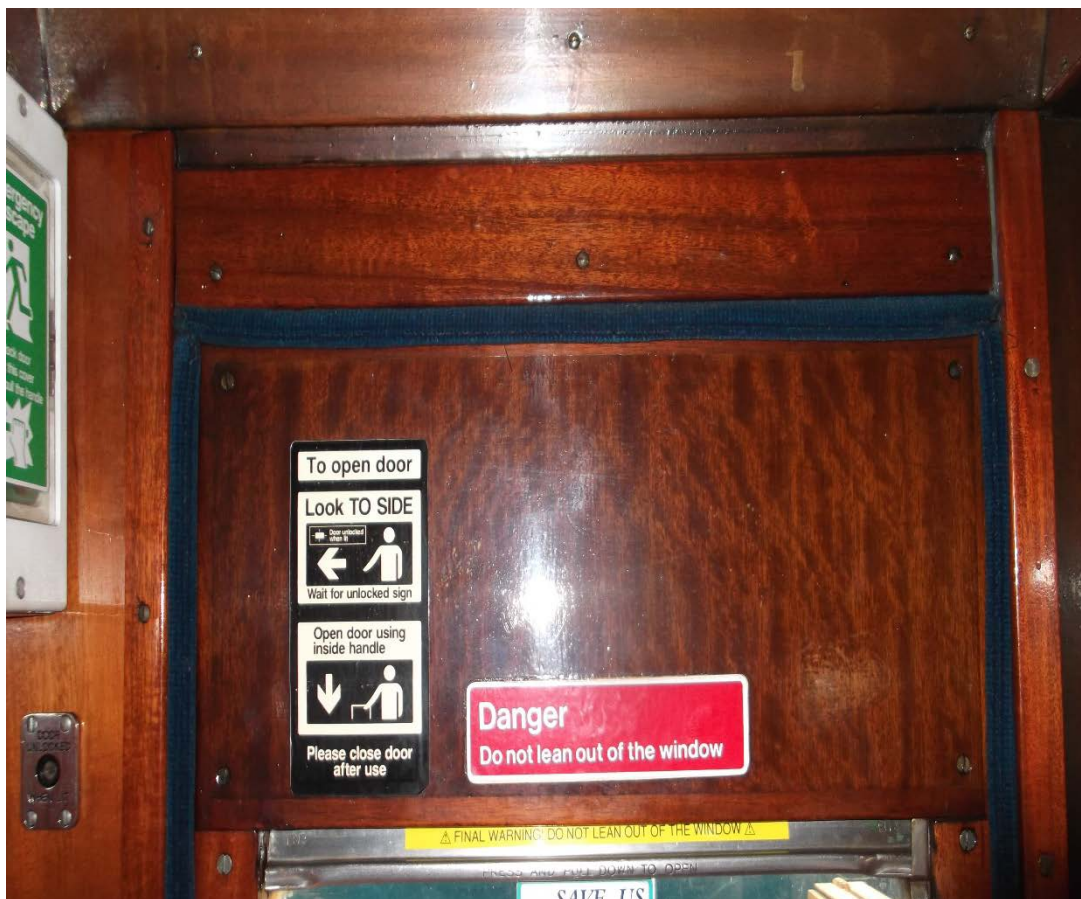
8. We have re-ordered our door signage to emphasise the warning notice and intend to provide an additional notice on the window release catch in black lettering on a distinctive yellow background, as shown below. This notice will be amended in the production version to read:

**A FINAL WARNING – DANGER OF DEATH – DO NOT LEAN OUT OF THE WINDOW**
