Andrew Eyles
RAIB Relationship and Recommendation Handling
Manager

7 October 2015

RAIB Report: Freight train derailment near Gloucester

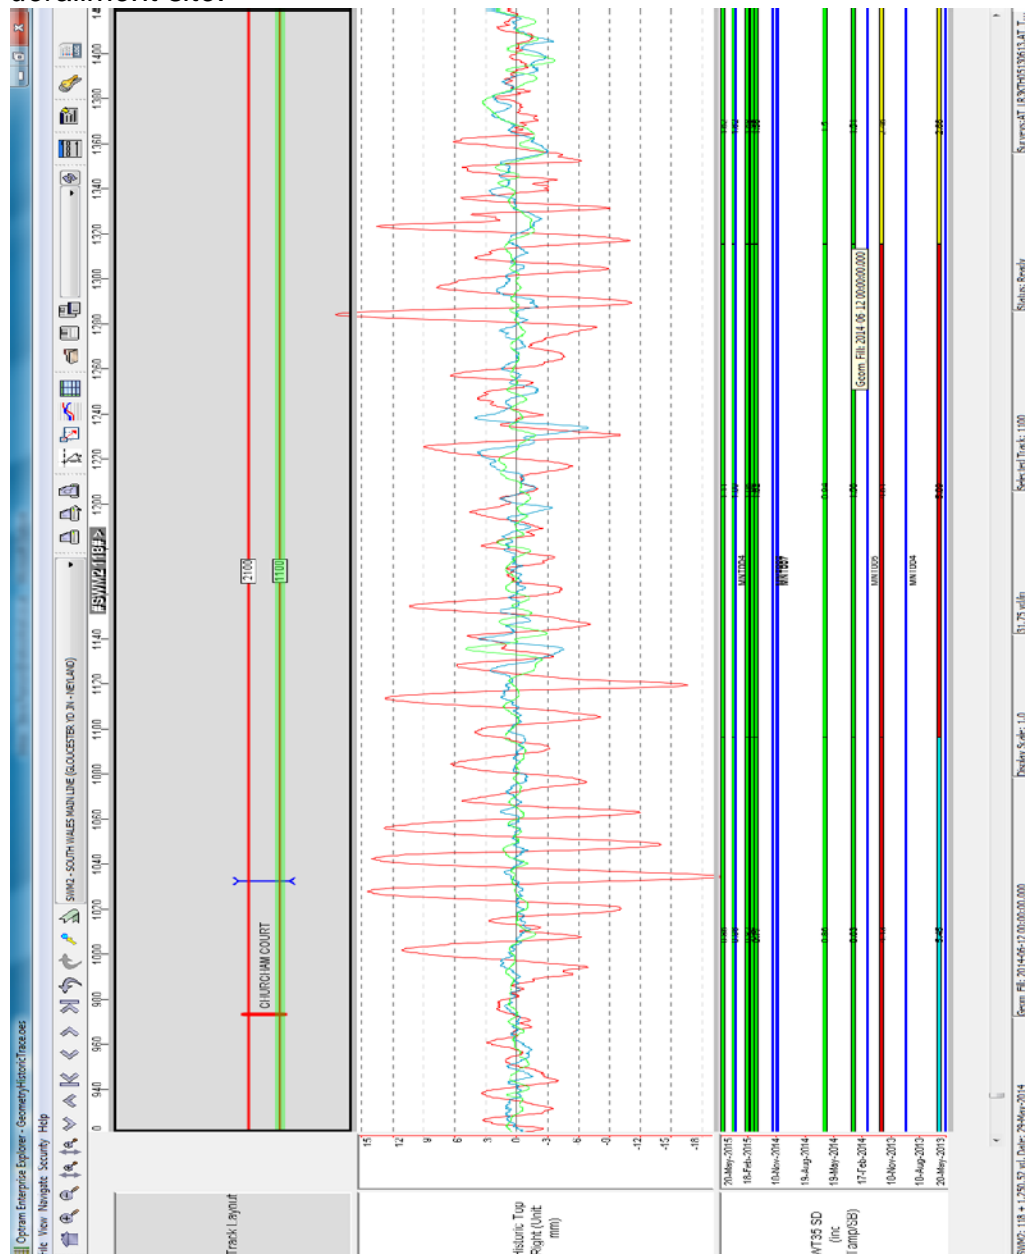
Track Geometry Analysis at 5 May 2015

The image has three sections. The top shows the track layout at the location, in this case a simple up line and down line. Superimposed on the diagram is the direction of the derailed train over the up line, and the point at which derailment occurred.

The middle section of the image shows the top trace, indicating vertical alignment. Right rail top has been used for simplicity although there was no discernible difference between both rails. The red trace is the top recorded on 13/6/13 before the derailment. Significant top faults are clearly evident on the approach to the point of derailment. The blue trace was recorded on 13/3/14 following track renewal and cess lowering to improve drainage, throughout the

length of the track shown in this image. The green trace was recorded on 1/5/15 and shows minimal change to the blue trace, indicating the sustainability of track quality.

The third section of the image shows successive track quality (WT35m) recordings since the derailment with the most recent at the top of the section. This shows the site was 'super red' at the time of the derailment (shown as light blue colour). Since renewal, this has remained in the 'good' band (shown as green). SDs have remained steady, well within the 'good band' limit of 2.2. This has been achieved without any significant interventions.

No alert or intervention limit track faults have been recorded.

The track asset is now in a good, sustainable position in the vicinity of the derailment site.
