Explosion inside an underframe equipment case at Guildford, 7 July 2017

Recommendation 1

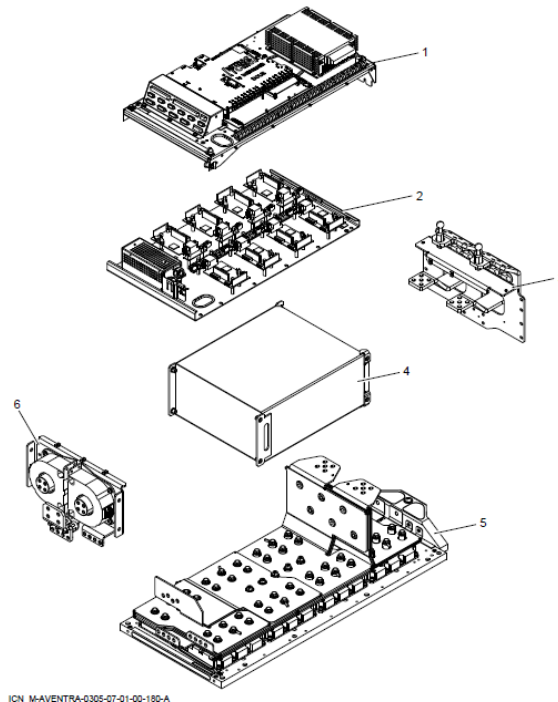
Mechanical separation and charging contactors are notably installed outside the sealed module.
