RAIB Report: Trains struck platform at Moston, Manchester, 28 January 2015

Initial consideration by ORR

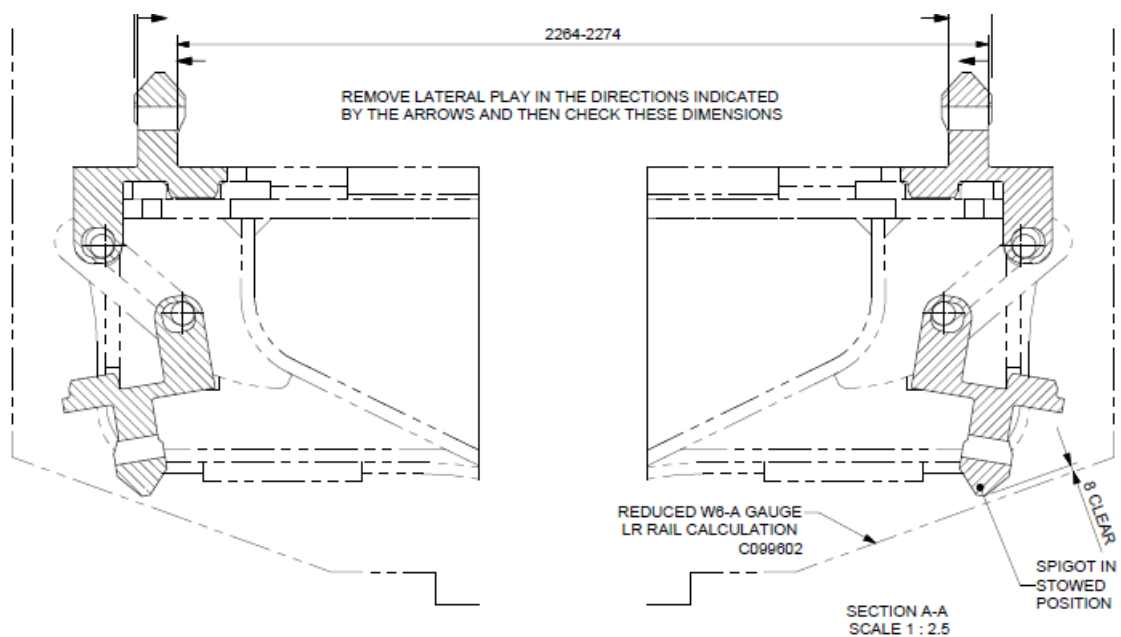
- The DRS owned fleet of IDA wagons have both UIC fixed and folding spigots of which all are painted white for ease of visibility to all personnel.
- The IDA wagon spigots that do fold all fall to the 'storage' position when not in use to within the W6-A gauge as shown on the W H Davis drawing 'RW 2088 – Installation of Flip Over Spigots Super Low (0996) issue C of which the relevant extracted section is as per the below:

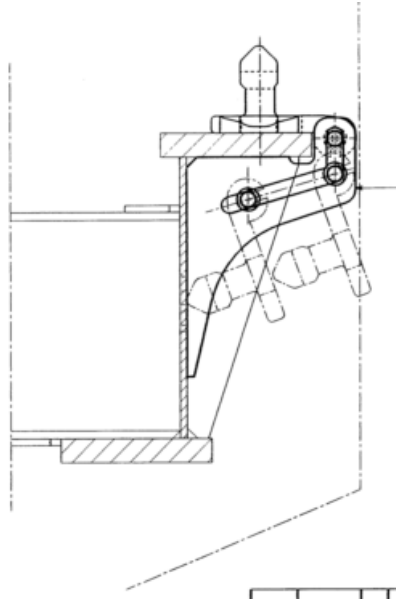
- The DRS fleet of IKA wagons of which DRS is the operator have both UIC fixed and folding spigots of which all are painted white for ease of visibility to all personnel.
- The IKA wagon spigots that do fold all fall to the 'storage' position when not in use to within the vehicle static gauge as shown on the Arbel Fauvet Rail drawing '1-612767 – Console Centrale issue D'

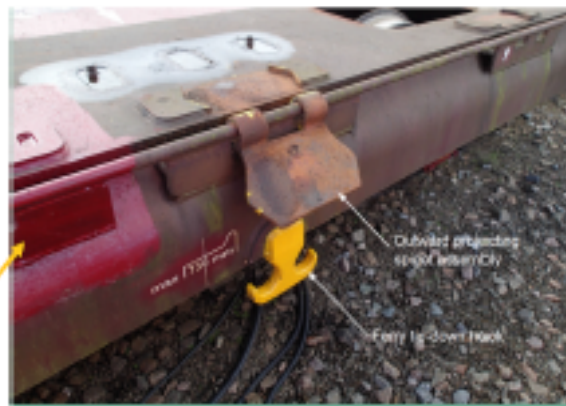
Spigot Recess

Your attention is drawn to a recent occurrence where substantial damage was sustained to line side infrastructure due to an outward rotating spigot assembly being left in an 'out of gauge' position in transit.

It is believed this condition was overlooked during train preparation, resulting in the vehicle entering the network in an unsafe condition.

Outward rotating spigots are being painted on the underside to enhance visibility of any rotated spigots. Please ensure during train preparation of these vehicles, that spigots not in use are either stowed in position on the bed of the vehicle (in the spigot pocket) or rotated outward and stowed adjacent to a spigot recess to ensure the spigot is then not out of gauge.
