Learning the lessons: ORR review into Hitachi AT200/300 rolling stock cracking

Final report

07 April 2022

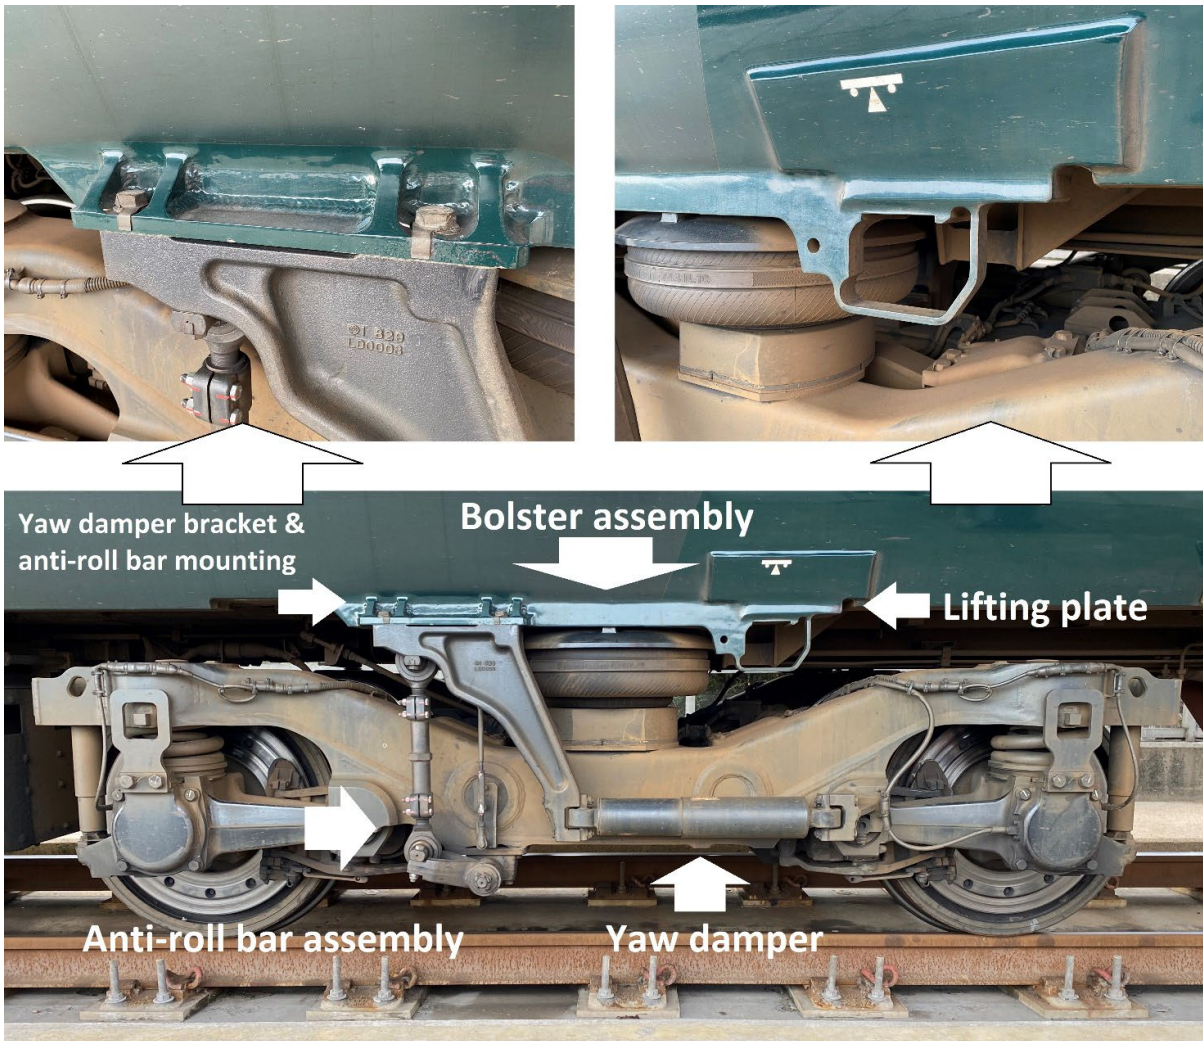
Figure 2.1 Anti-roll bar & yaw damper connection points, and lifting plate (intermediate vehicle)

- 2.1 During scheduled maintenance activities on GWR Class 800 and Class 802 units, cracks were found in the area of the bolster close to the yaw damper bracket and anti-roll bar fixing points (see **Figure 2.1** below) on vehicles in these classes.

- 2.13 **Figure 2.1** below, shows the particular features to note, including the connection points for the anti-roll bar and the yaw damper between body and bogie, and a lifting plate used when the vehicles are being lifted for maintenance.
