RAIB Report: Fatal collision between a tram and a pedestrian, near Saughton tram stop, Edinburgh on 11 September 2018

Non-Motorised User Crossing Risk Assessment: Saughton Mains	ET/NMUC/10 ~ v1.0	
		Issue Date: 31-Jul-19	Review Date: 31-Jul-20

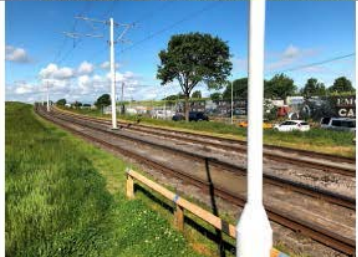
Part (B) Crossing Approaches and Environment (insert photographs as titled. Landscape photos need to be height 6cm or 6.5cm to fit in):			
	LOOKING AIR-BOUND [towards Airport] (AB)	CENTRE OF CROSSING	LOOKING CTY-BOUND [towards City] (CB)
CTY-BOUND SIDE (CS)	 	 	 
AIR-BOUND SIDE (AS)

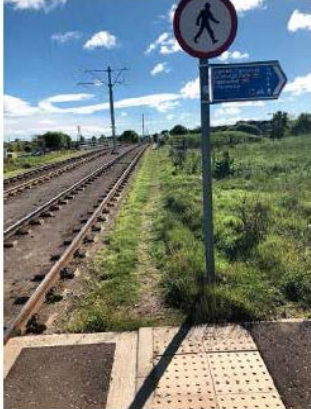
Desire line on AIR-bound side, between NMUC/10 and SGT tram stop (1)	Desire line on AIR-bound side, between NMUC/10 and SGT tram stop (2)	Desire line on AIR-bound side, between NMUC/10 and SGT tram stop (3)

8	Pedestrian 'Transition to High Risk Area' Markings or Indication	Tactile paving present	Blue 'Tramway: Look Both Ways' signage present (both head-height and ground). Also kick rails and tactile paving	5 (2+3)	7 (1+4)	35	Paint hazard zones yellow A001	3 (1+2)	7 (1+4)	21
9	Impact on pedestrian position (anything that may affect pedestrian approach)	Desire lines (Same as row 13)	None	6 (2+4)	7 (1+4)	42	Implement measures to mitigate multiple desire lines A020	3 (1+2)	7 (1+4)	21

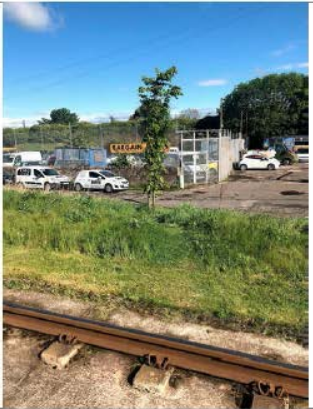
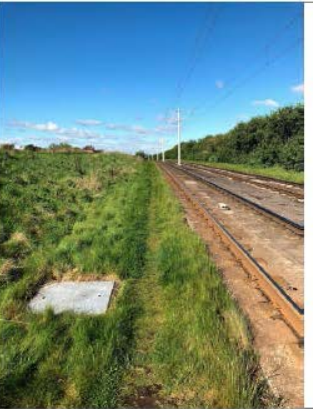
Desire line on CTY-bound side, between NMUC/10 and SGT tram stop	Desire line on AIR-bound side, west of SGT tram stop (1)	Desire line on AIR-bound side, west of SGT tram stop (2)

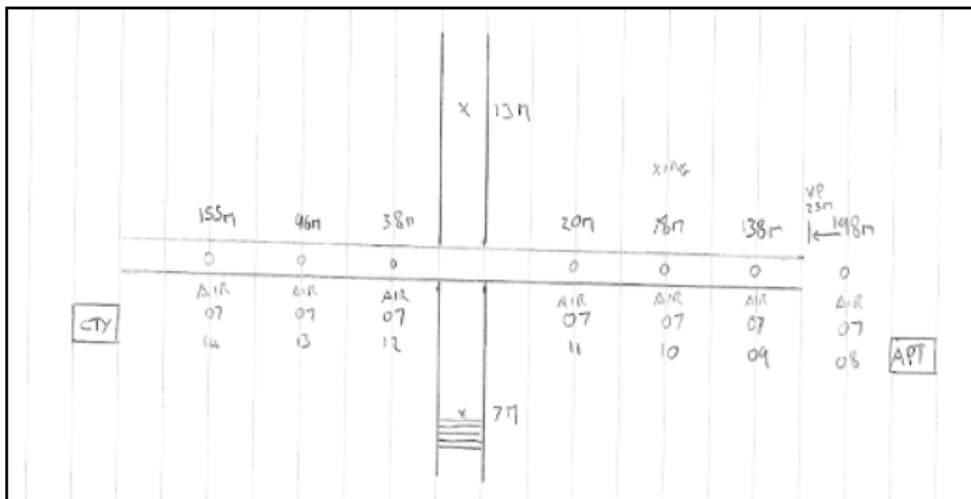
Appendix: Sketch of Crossing

The proposed measures being implemented to mitigate the RAIB report recommendations include:

Action Ref	Action Required	Status
A001	Paint hazard zones yellow	Completed
A002	Consider further measures that control the speed of crossing users and encourage persons to look for the presence of approaching trams (chicane, bollards etc) Recommendation to use Bollards instead of chicanes due to spatial constraints is documented in Edinburgh Trams - Chicane Design Issues (September 2019)	Completed
A003	Implement underrun protection in accordance with emerging LRSSB Underrun Protection Guidance	Completed
A015	Consider cutting back foliage on left of photo CS-CB	Completed
A020	Consider measures to mitigate multiple desire lines Documented in Edinburgh Trams - Chicane Design Issues (September 2019) Appendix 3 Additionally implement anti-pedestrian deterrent measures at all crossings.	Completion Due - date end Dec 19
A023	Review crossing warning signage relevant to crossings See Notes in ET/NMUC/010 Part F Risk Assessment and response to Recommendation 1 b) in this letter.	Completed
